ERDC/EL TR-01-28

# **Design, Construction, and Operation of a Field Demonstration for In Situ Biodegradation of Vadose Zone Soils Contaminated with High Explosives**

Ken Rainwater, Justin Brown, Caryl Heintz,  
Tony Mollhagen, and Lance D. Hansen

September 2001

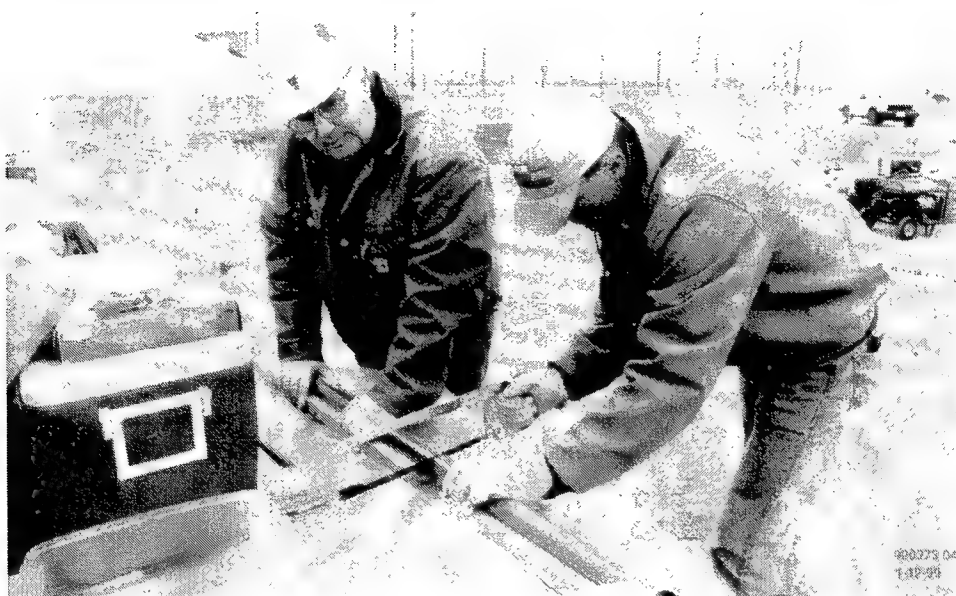
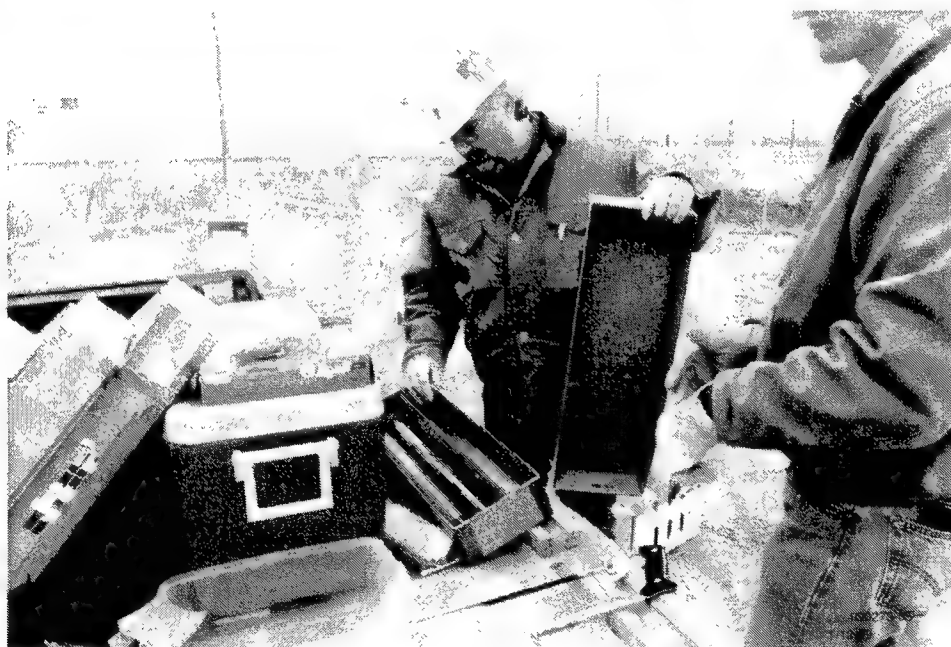
Figure 6. Preparing and handling of soil cores

As the holes were bored, 4-ft core samples were collected in clean plastic liners from the geoprobe rig. The ends of each section were sealed with rubber end caps to help maintain the original soil conditions. These samples were then cut into 2-ft sections using a sterile hacksaw blade and placed into core boxes to prevent direct contact with sunlight. Preparation and handling of core samples can be seen in Figure 6.

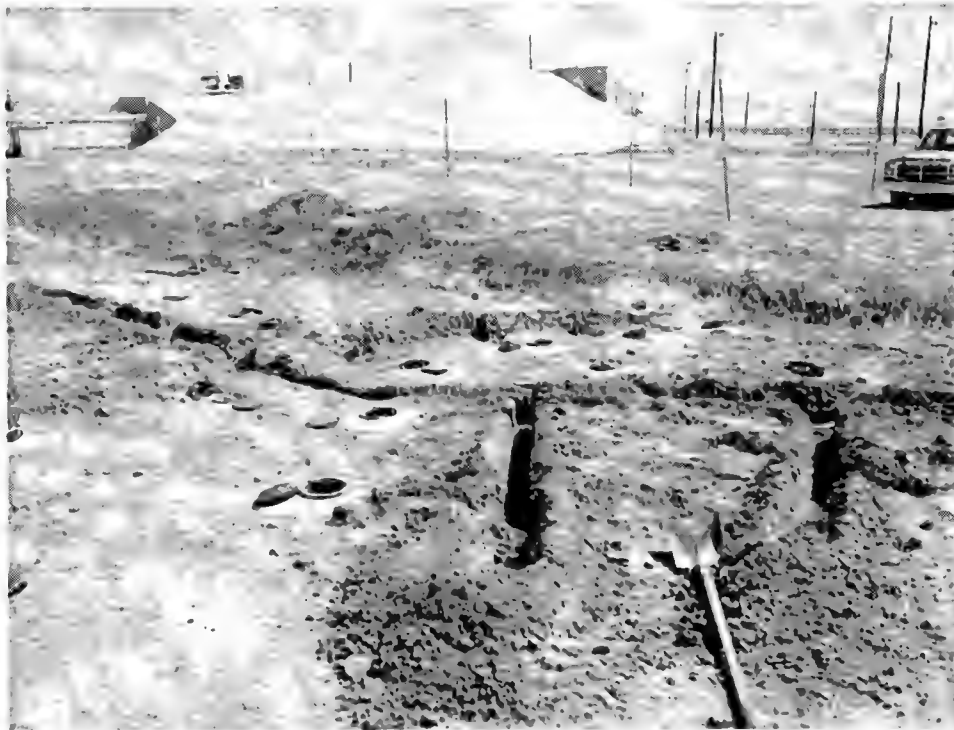
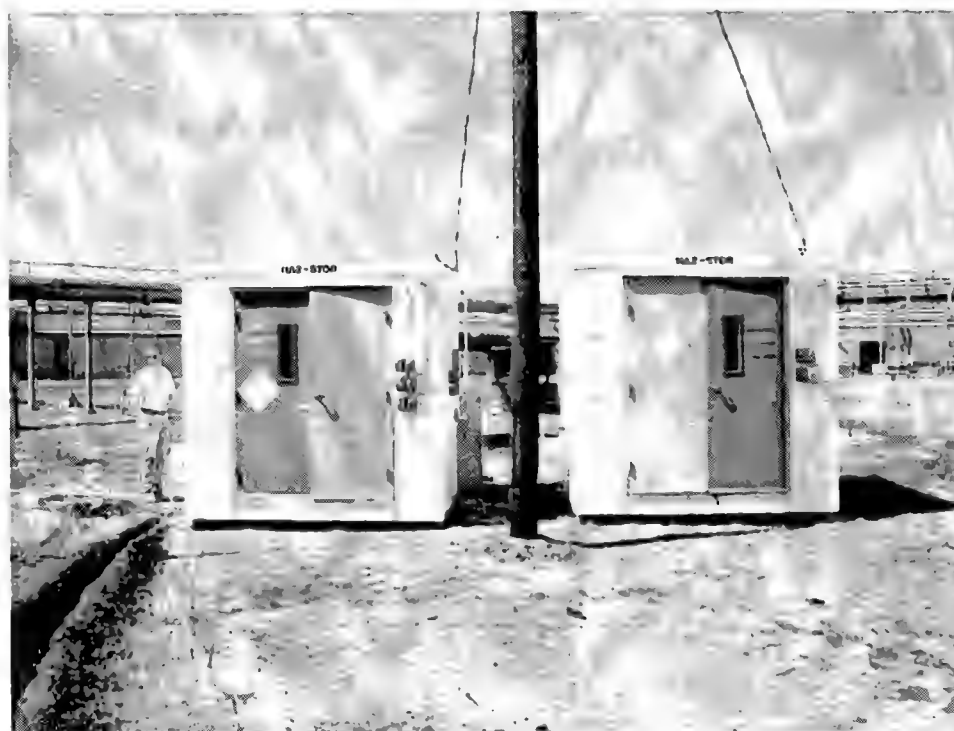
Figure 10. Installation of plumbing and control buildings

the plumbing work and control buildings can be seen in Figure 10. The two 10-ft by 10-ft control buildings were placed approximately 150 ft southwest of the field well site. One control building housed most of the plumbing work, valves, flow meters, and extraction pumps. The other control building housed the liquid nitrogen cylinder, water column, and gas-monitoring devices.
